FRI-8.121-1-AMT&ASVM-01

STUDY OF VIBRATIONS CAUSED BY ROTARY MOVEMENT OF ELECTRIC MOTORS

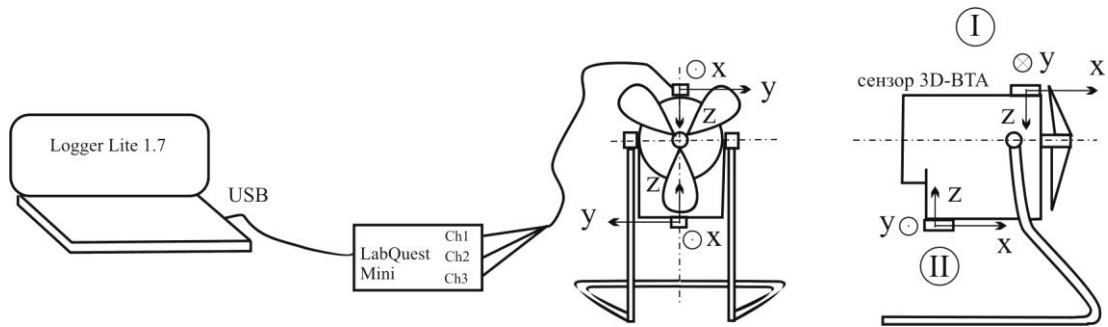
Fig. 1. Block shceem and positions of vibrosensor type 3D-BTA on fan

Figure 1 shows the way in which the vibrosensor is mounted when recording a vibrogram from a fan according to the requirements of ISO 10816-I, First edition 1995-1-2-15, GOST ISO 10816-1-97. The sensor does not need to be calibrated before starting the vibrogram recording. It is enough just to "reset" the Logger Lite 1.7 application with the "New" command from the "File" menu. The symbol \odot is the direction of the axis towards us from the plane of the figure, and the symbol \otimes - from us to the plane of the figure.

The vibrations occurring in the test objects are recorded by a 3D-BTA vibrosensor, which is a tri-axial accelerometer within $\pm 5g$ (where $g = 9.8 \text{ m/s}^2$). The sensor is connected via LabQuest® Mini, to computer by electronic adapter of the company (www.venier.com), as shown in Figure 1.

Table 1 gives data about the values obtained after applying the Fourier Fast Transform to the frequencies and amplitudes of the harmonics involved in the measured signals in points I, II, III, IV on the X, Y and Z axes of the fan, (Fig. 1.) and abraze tool, (Fig. 3.).

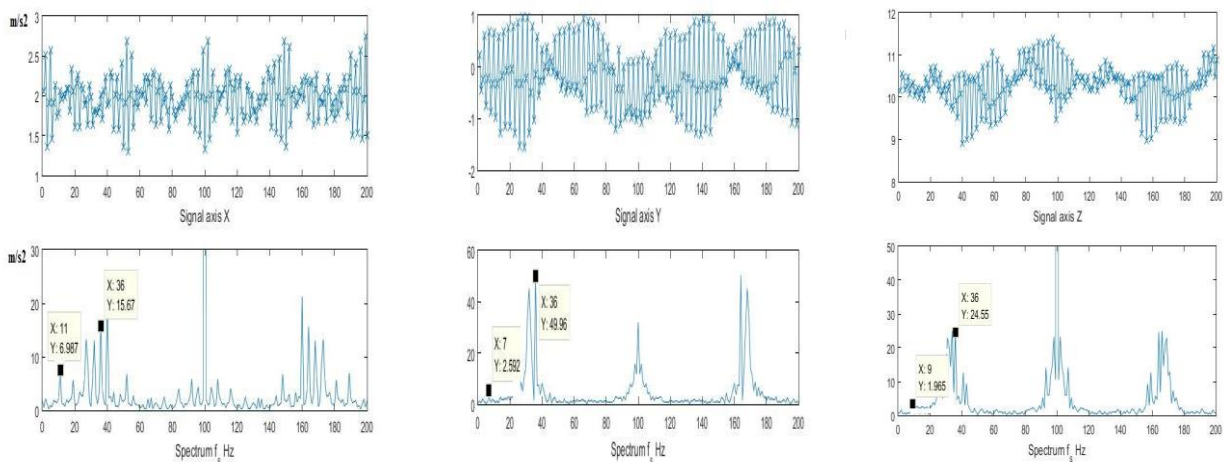
The recorded vibrogram with the Logger Lite 1.7 software is exported in a text format and after the corresponding processing with a special program in the MatLab environment the graphs shown in Figure 2 are obtained. In the Logger Lite program, the value f_s - sampling frequency is set beforehand. That is the record frequency that complies with Nyquist's condition to be twice as high as the maximum bandwidth we record. This value automatically determines the recording interval, Δt digitization, the vibrogram and the number of recordings N . For current measurements, a signal recording frequency is equal to the limit of 100 Hz, i.e. 100 Hz, is selected. The program measures the values of the signal at an interval of $\Delta t = 0,01 \text{ s}$, which represents $N=200$ counts within 2 seconds (Figures 2 and 4).

Fig. 2. Signal and spectrum at point I along axes X, Y, Z of the fan

The vibrations graphs and amplitude-frequency characteristics shown in Figures 2 and 4 are for the vibration acceleration, which dimension is m/s^2 . According to standard GOST ISO 10816-1-97 Annex A, the vibration state of the machines is assessed by the mean-square magnitude of the vibration velocity. In order to obtain this magnitude, it is necessary to divide the acceleration value into $2\pi F_1$, taking into account the fact that the velocity is measured in the dimension [mm/s], where F_1 , (see Table 3) is the base frequency from the revolutions of the rotating shafts. The vibrational amplitude is calculated in a similar way in [μm].

1. Axis X longitudinally to a fan has a frequencies of 7 to 11 Hz, which are caused by the solid base on which it is placed;
2. From the measured oscillations on each of the three axes X, Y, Z (Fig. 2.) of the fan respective the sensor axes, the basic frequency of 36 Hz (see Table 3) is recorded, which is excited by the

velocity of the blade rotation. The blade is not dynamically balanced and this is why this frequency is dominant.

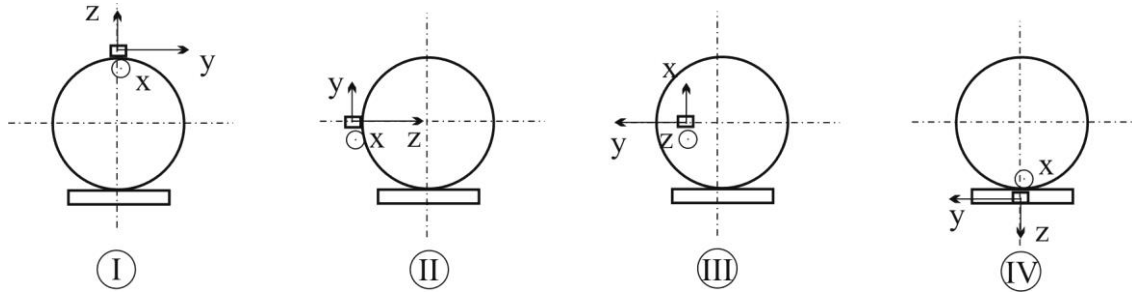
Figure 3 shows the locations where the vibrosensor is mounted when removing the signal form abraive tool. They comply with the recommendations in standard ISO 10816-I, First edition 1995-1-2-15, GOST ISO 10816-1-97.

Fig. 3. Position of vibrosensor type 3D-BTA at point I, II, III and IV on abrasive tool.

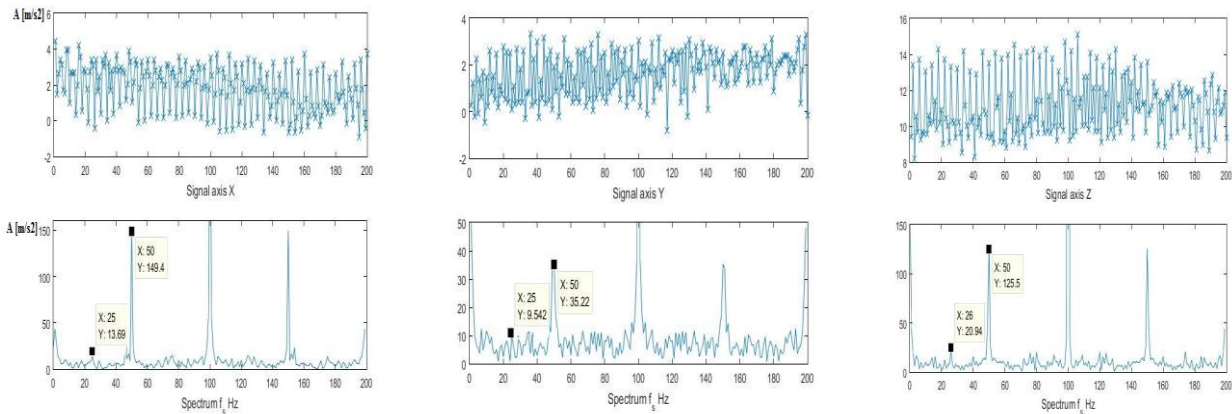
Fig. 4. Signal and spectrum along axes X, Y, Z at point I of the abrasive tool.

The analysis of the results of the vibrograms and the resulting amplitude-frequency characteristics of the abrasive tool placed on a rigid base show that in all the vibrograms the phenomenon "beating" is observed, which is an indication of the presence of a defect in the bearings and disbalance of the abrasive disk. These facts are grounds for believing that there is a developed defect in the bearings in the second diagnostic stage, (Rusov V.A. 2012).
